Loon Lake Integrated Aquatic Plant Management Program

Prepared for:
Loon Lake Park District Association &
Town of Chester
September 2010

Prepared by: Lycott Environmental Inc. Southbridge, MA USA
Richard King & Erin Miller

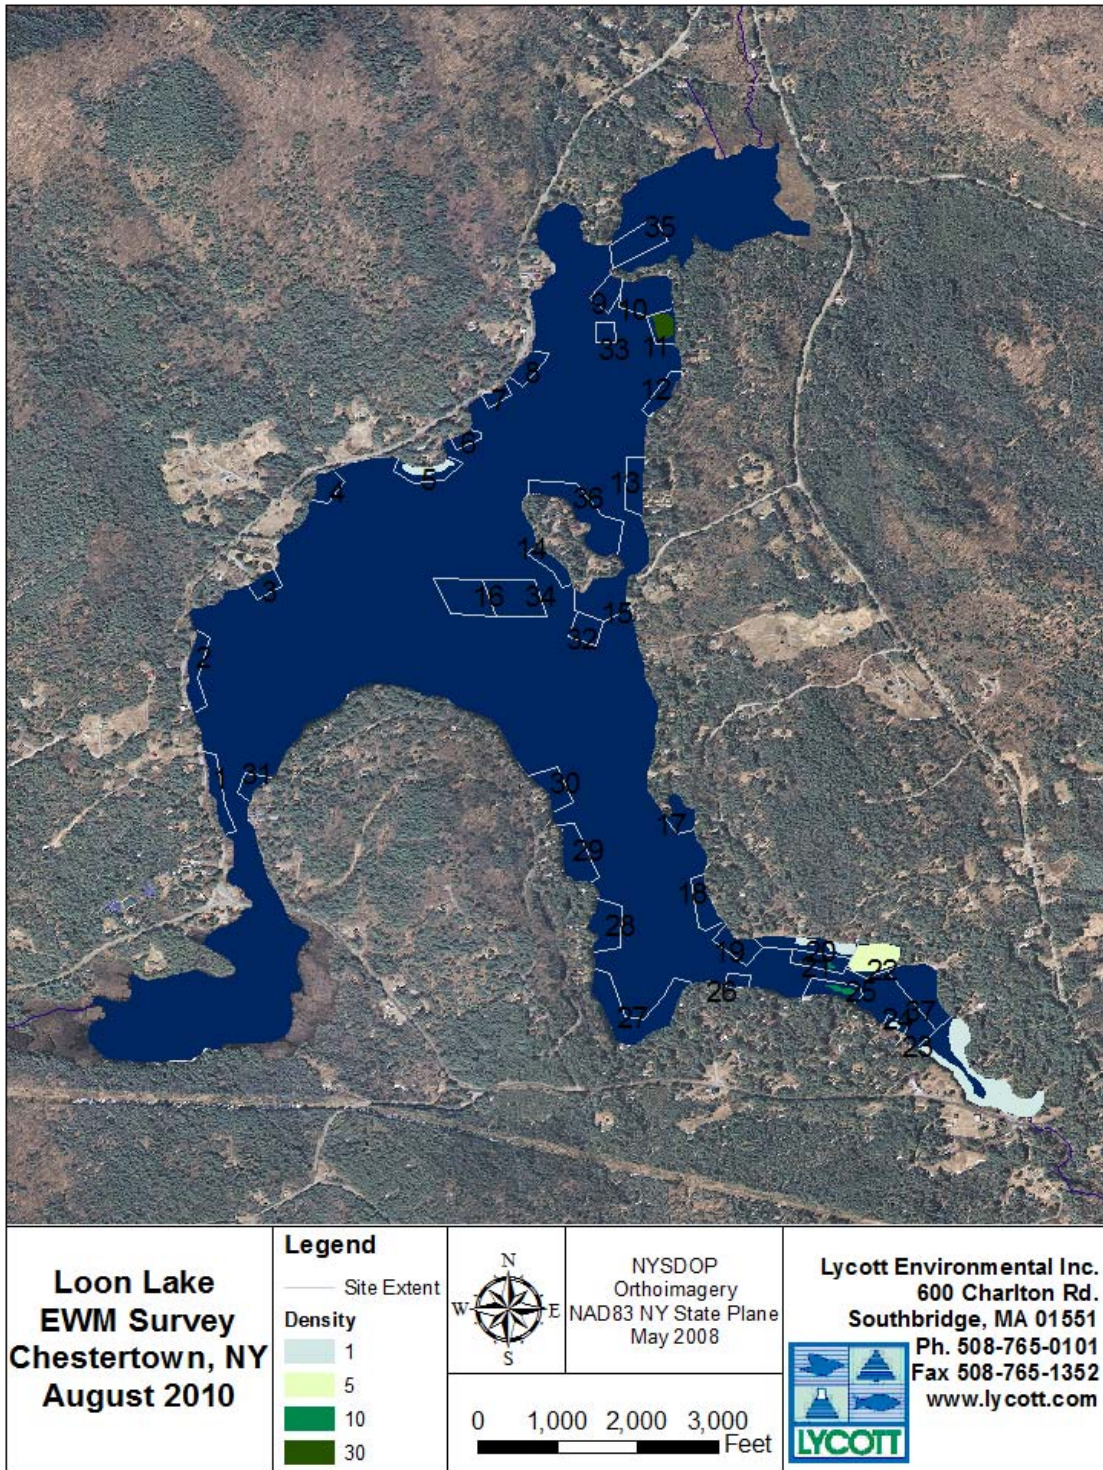
Figure 2. Site locations, numbers, boundaries and density post--management, August 2010.

Twenty-eight of the 37 sites were cleared by hand harvesting, five sites were reduced using hand harvesting and/or benthic barriers and four sites were not managed at all in 2010 due to time constraints (Figure 2). Lycott and LLPDA removed 26,947 and 1,703 plants respectively by hand harvesting. A total of 58 (375 sf) barrier panels were installed across sites 5, 11, 18 and 34 (two installations of 29 panels each) and 10, (100 sf) panels were installed at site 32 by LLPDA. Twenty-nine panels remain in place at site 11 and the LLPDA panels remain at site 32. Panels used by Lycott are 7.5'x50,' those installed by LLPDA were 10'x10.' Thus a total of 21,750 sf of barrier material was installed by Lycott and 500 sf by LLPDA. Due to necessary overlap of panels, actual combined coverage was ca. 19,250 sf. Average plant density at install sites was calculated to be 1.7/sf. Thus, Lycott and LLPDA barrier coverage removed an estimated 32,045 and 680 plants respectively. The combined total number of plants removed from Loon Lake in 2010 from hand harvesting and benthic barrier placement was 58,992 by Lycott and an additional 2,383 by LLPDA; for a total of 61,375 plants. Site 11 and most of the outlet sites will require significant management in 2011 (Figure 2).

Even though most sites were cleared through 2010 efforts, a large milfoil bed remains in place at site 11 and moderate to dense growth remains at several locations near the outlet. Moreover, physical management can generate plant fragmentation. Therefore it is anticipated that most of the cleared sites will have some level of milfoil regrowth in 2011.
